**MANAGEMENT SUMMARY OF DATA RECOVERY
EXCAVATIONS AT 38CH2091,
A ST. PAUL PARISH PLANTATION,
CHARLESTON COUNTY, SOUTH CAROLINA**

CHICORA RESEARCH CONTRIBUTION 491

Prepared By:
Michael Trinkley, Ph.D., RPA,

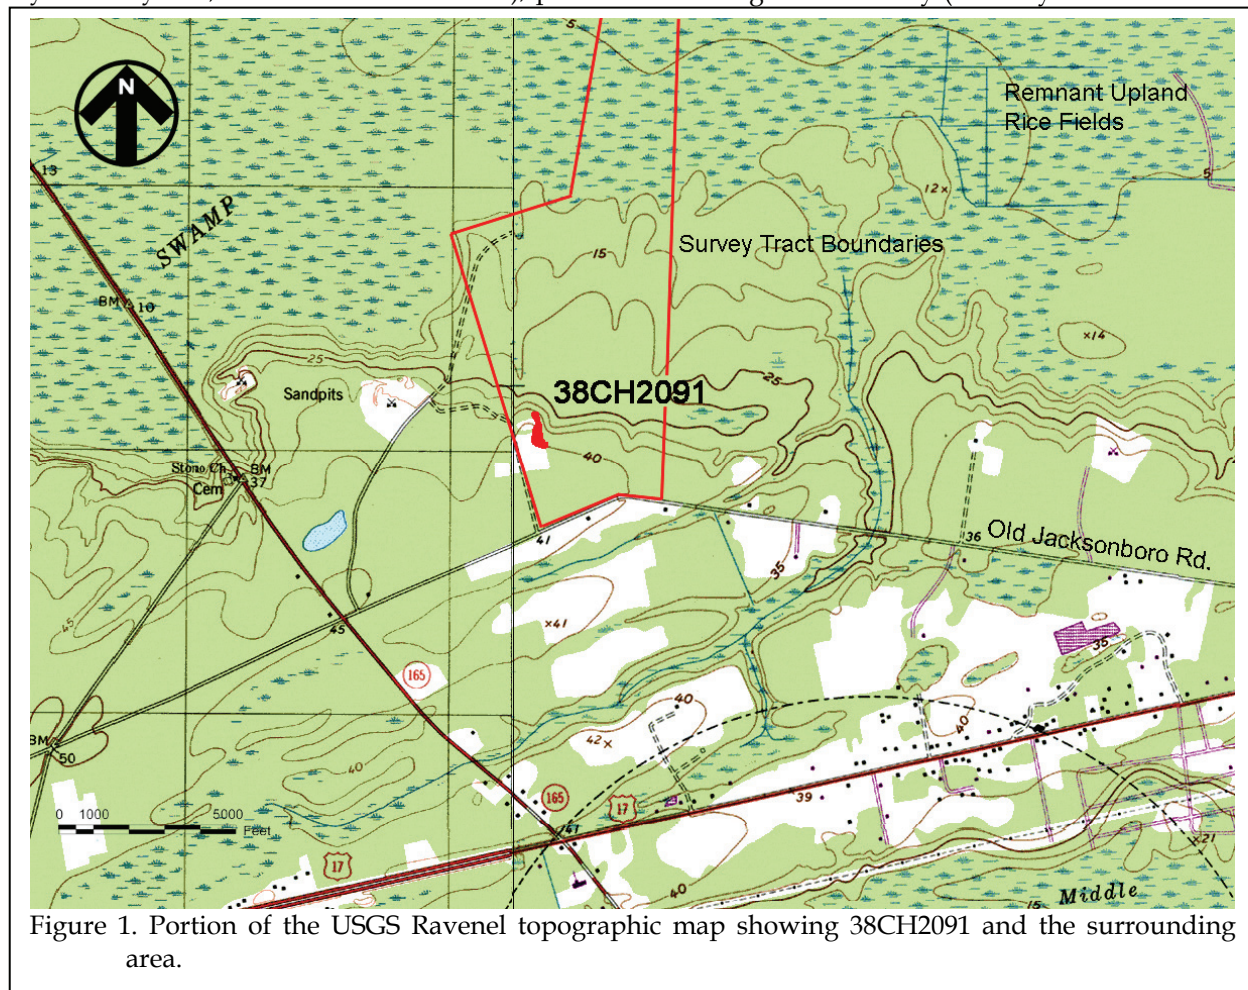
The site was situated in an upland area at the edge of the bluff overlooking the Caw Caw Swamp to the north. Elevations were about 30-35 feet AMSL and the soils were sandy and well drained (Figure 1).

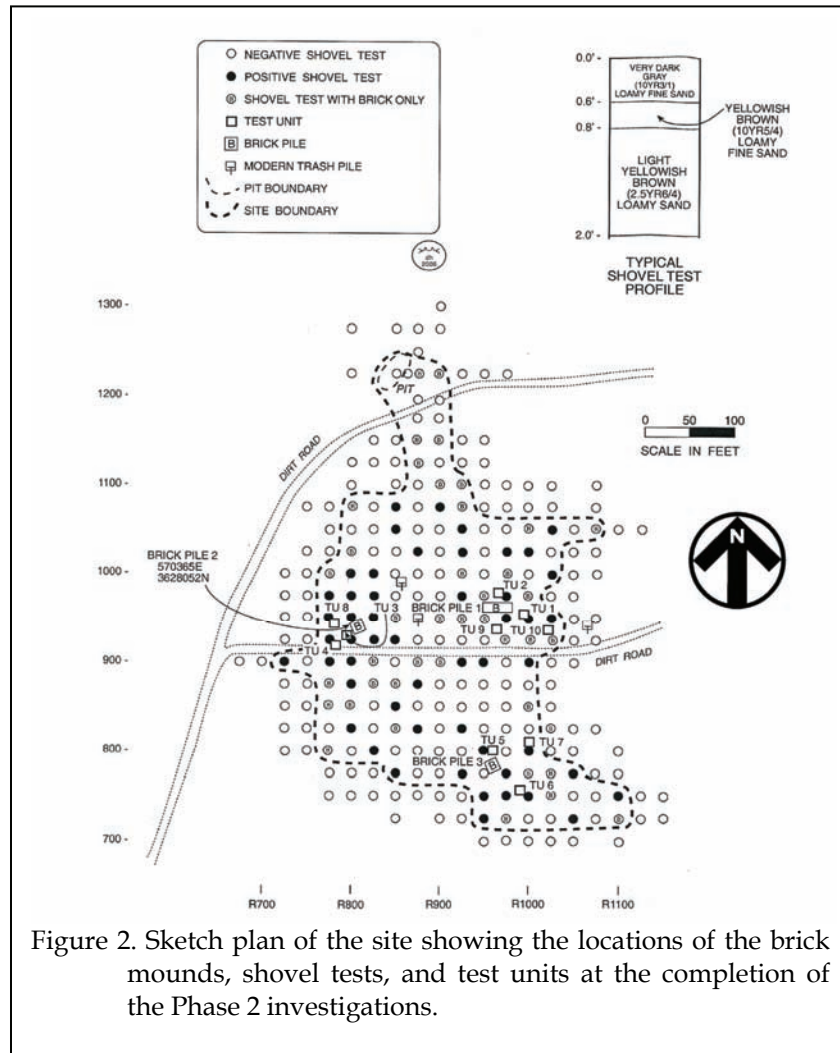
Figure 2. Sketch plan of the site showing the locations of the brick mounds, shovel tests, and test units at the completion of the Phase 2 investigations.

Brick pile 1 was the largest scatter, extending almost 30 feet. No intact brick was found and three of the four test units (TU 1, TU 2, and TU 9) produced a layer of very dark grayish brown (10YR3/2) sand, representing a burn layer. Burned artifacts and melted glass were recovered from several of the test units.

Brick pile 2, to the west, appeared smaller, with the brick more scattered. Subsequent examinations (with the area cleared

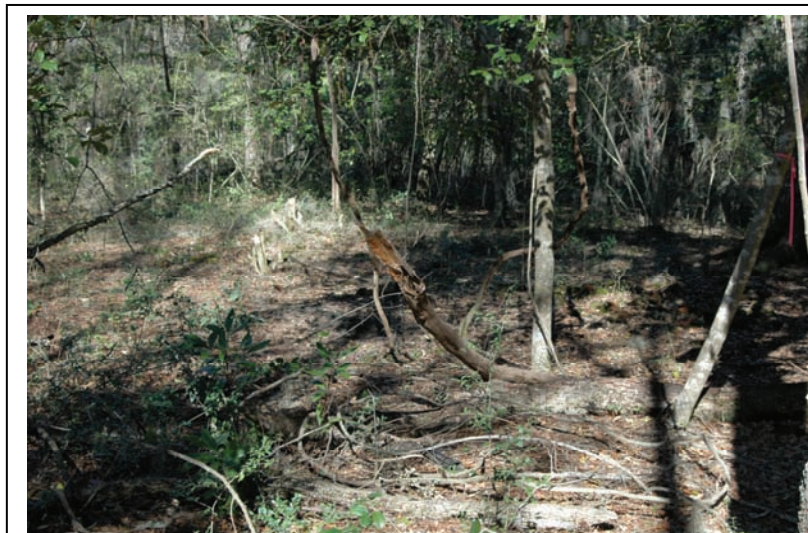
Figure 3. Area of brick pile 1, looking north.

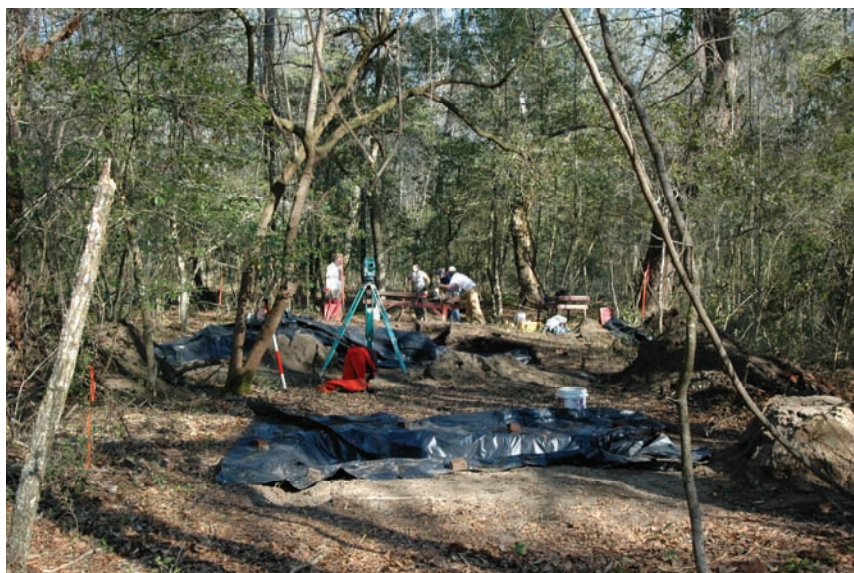
Figure 4. Brick pile 2, excavations in progress, looking north.

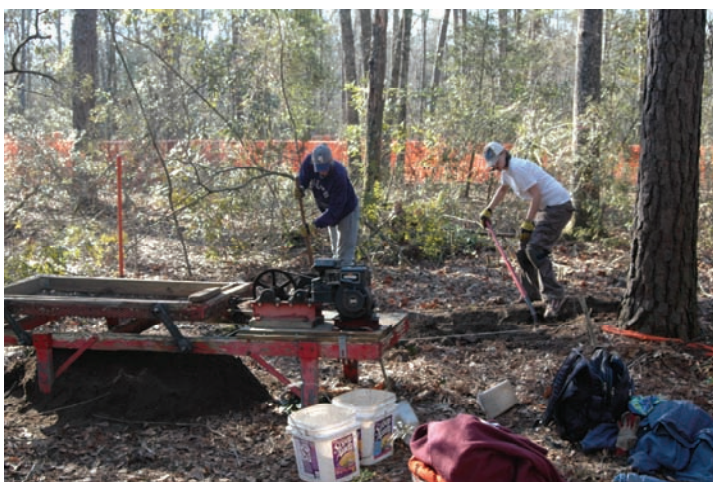
Figure 5. Brick pile 3, looking southeast.

Brick pile 3 was a small (and low density) brick scatter compared to the first two loci. In addition, artifacts were less abundant with three test units (TU 5, TU 6, and TU 7) producing less than 20 specimens each.

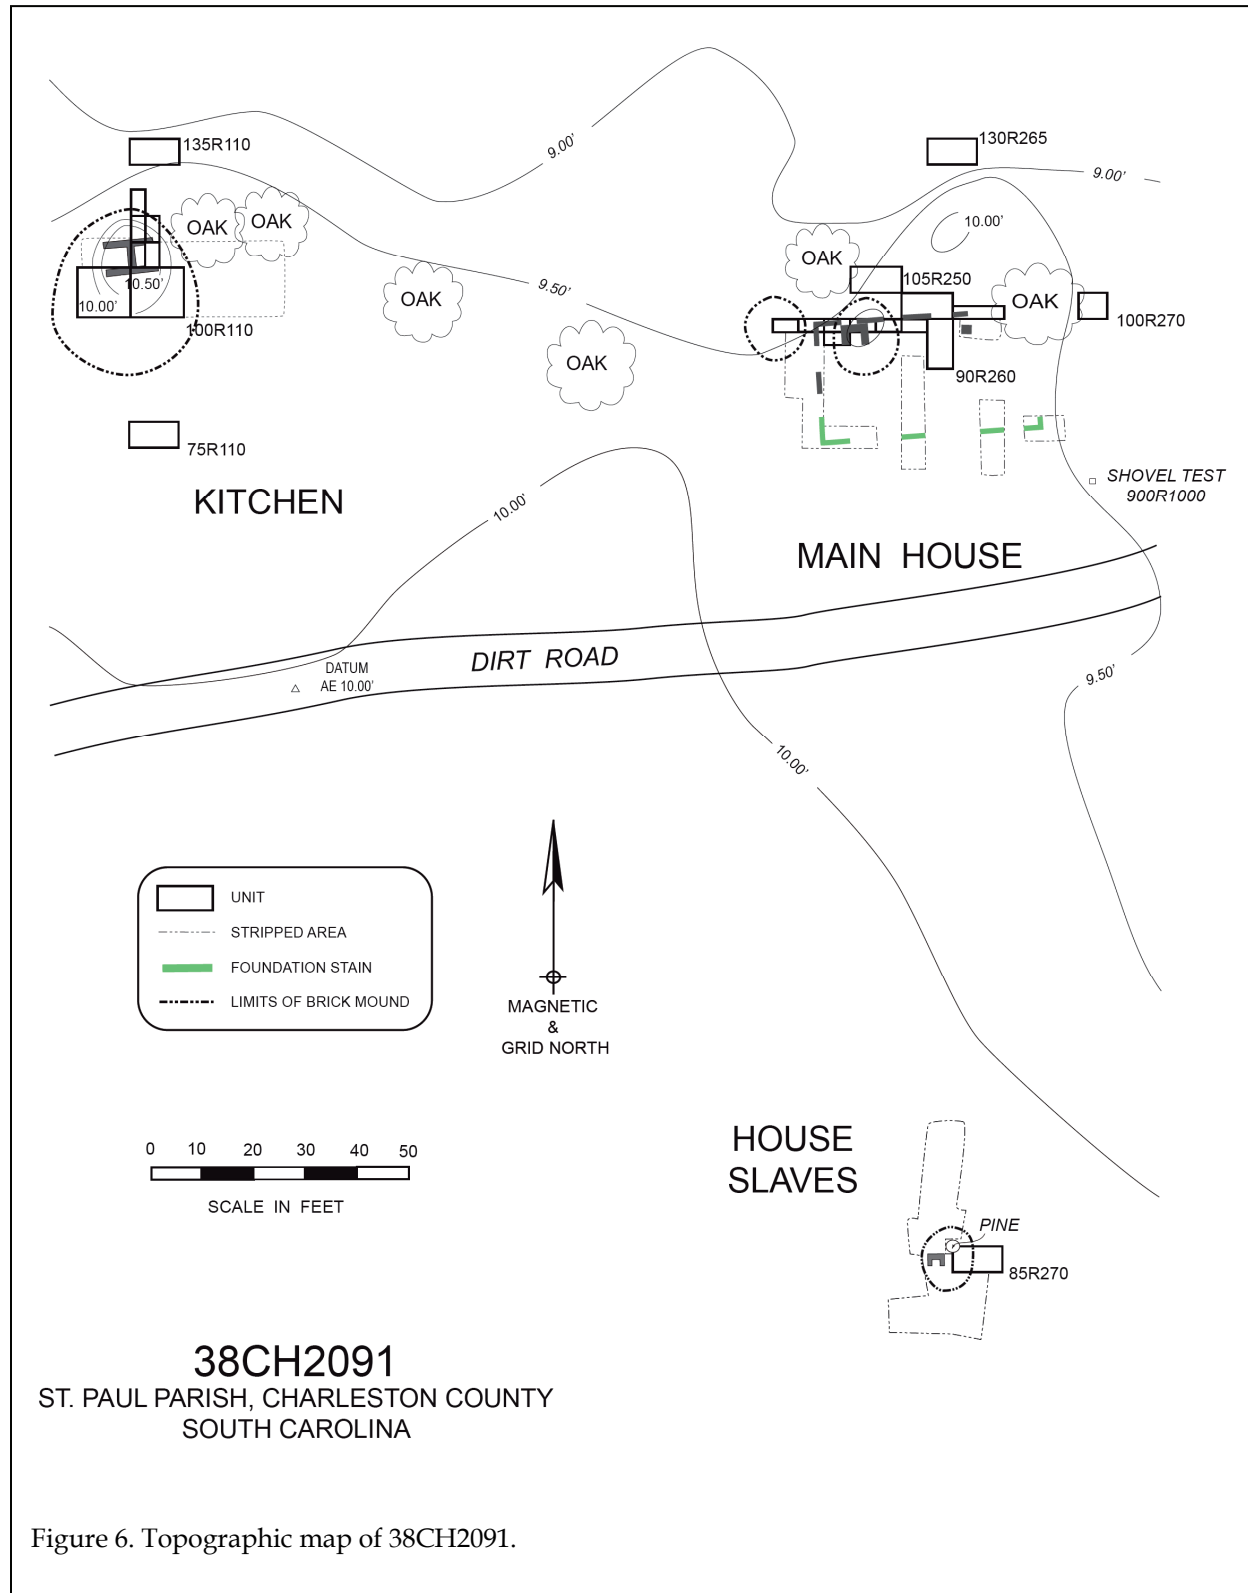
Figure 6. Topographic map of 38CH2091.

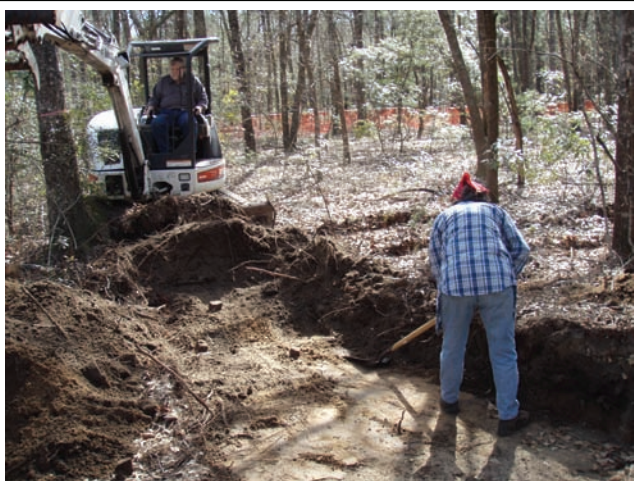
Figure 7. Stripping using a Bobcat and a toothless bucket followed by flat shoveling.

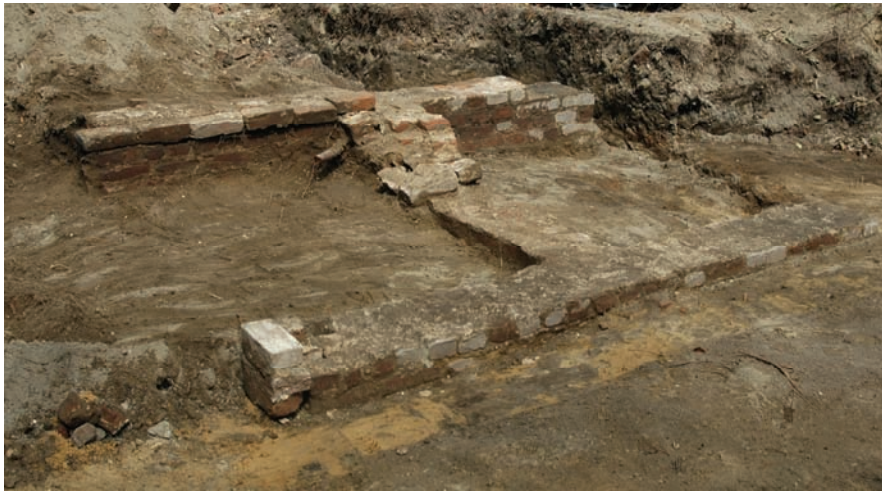
Figure 8. Chimney exposed in the western brick mound, view to the northeast.

These units immediately produced a brick wall oriented just off east-west that measured about 9 feet in length and was a double wythe of brick (about 1.1-1.2 feet). The stratigraphy evidenced two distinct zones. The upper, about 0.7 foot in depth, consisted of a black (7.5YY2.5/1) loamy sand with dense rubble. Below was a dark brown (7.5YR3/3) loamy sand with little or no rubble. Zone 1 represents building collapse or demolition, while Zone 2 likely represents original A horizon soils and sheet midden built up around the structure. Zone 2 graded into a brownish yellow (10YR6/6) sand that was frequently heavily mottled. This represents the subsoil at the site.

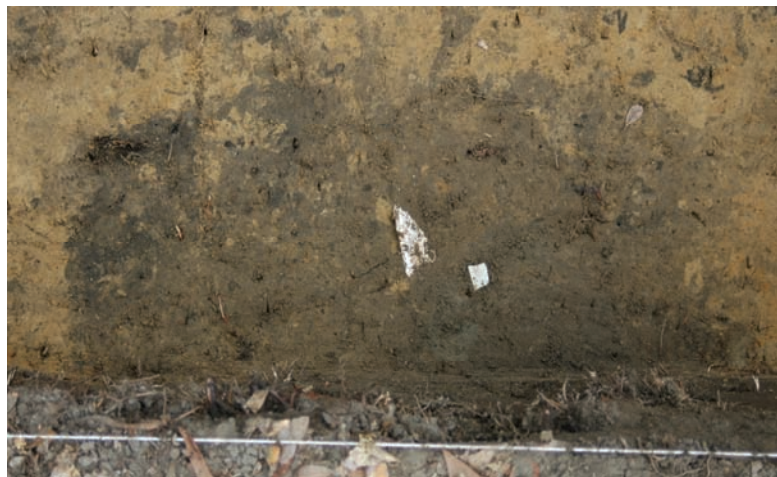
Figure 9. View of Feature 1 before excavation. North is at top.

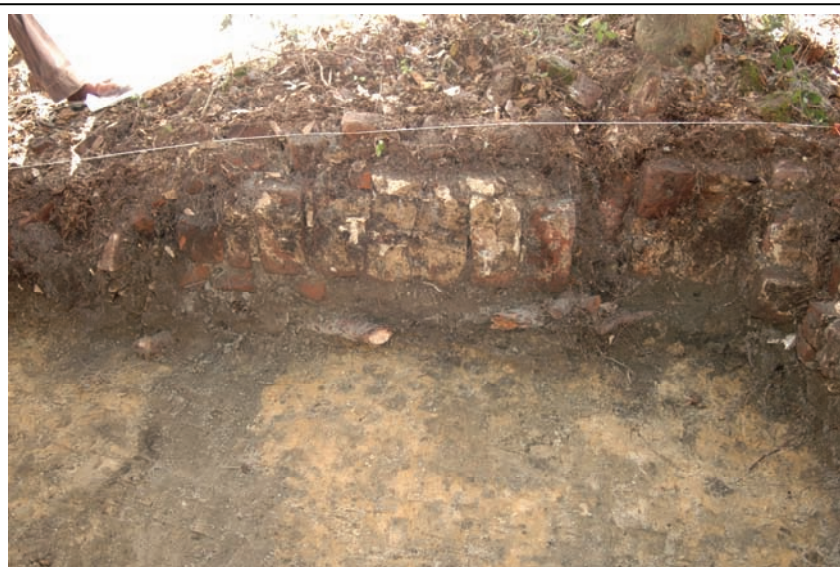
Figure 10. Brick wall fall in the south profile of 105R250, looking south.

produced far fewer artifacts. Stratigraphy was simple, consisting of very dark brown (7.5YR2.5/3) loamy sand and dense brick rubble overlying a mottled brownish yellow (10YR6/6) subsoil sand.

the wall fall was most likely associated with a nearby chimney.

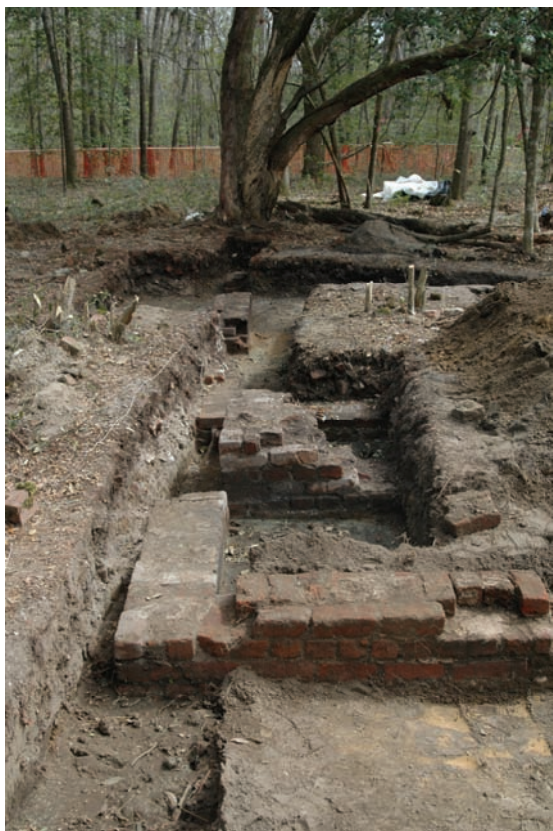
Figure 11. North wall of the eastern structure exposed by excavations and stripping. View to the east.

Stripping was necessary to completely expose the structure. The western wall pier was found intact, piers for the southwest and southeast corners, as well as the south wall, were evidenced only by remnant stains. It appears that the piers in these areas had been robbed out. This robbing episode appears to correlate with differences in soil texture – indicating that the area south of about N80 line has been cultivated in the past. It is likely that the main house rubble was left largely intact at the edge of an agricultural field, representing too much effort to clear the debris.

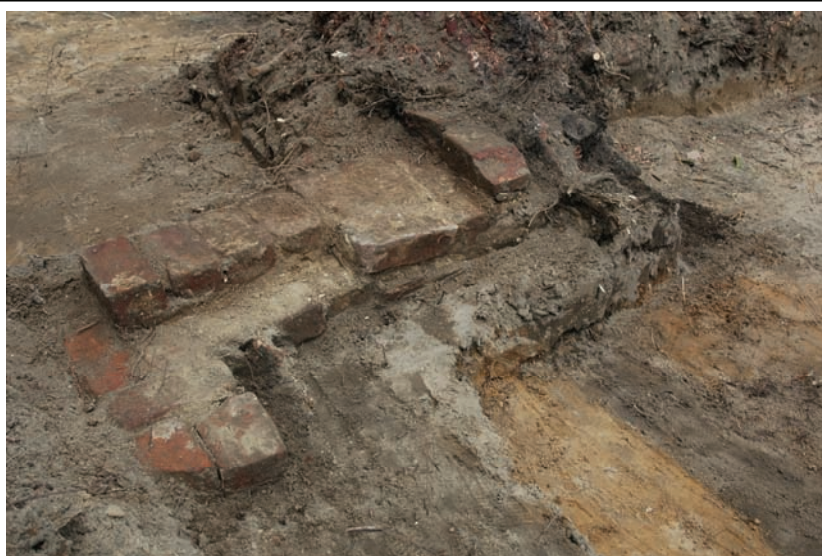
Figure 12. Brick fire box in the southern brick mound exposed by stripping. Unit -85R270 is situated to the upper right. The east (right) arm of the fire box was no longer in situ because of tree roots. View to the northeast.

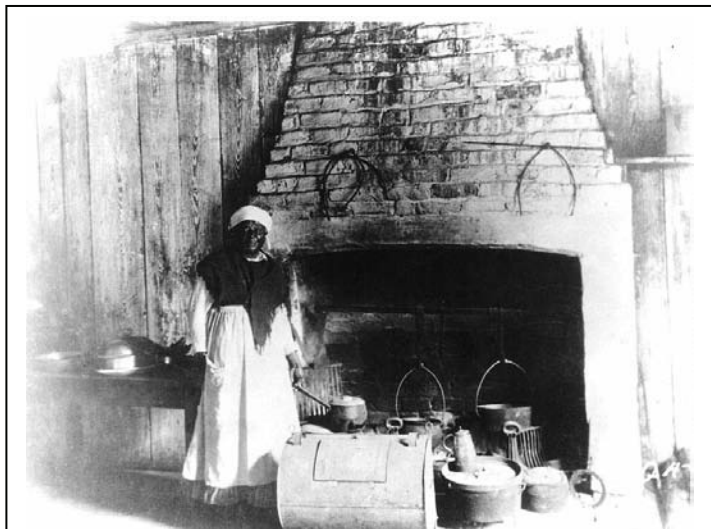
Figure 13. Photograph of the Refuge Plantation kitchen, Camden County, Georgia in 1880 (Historic American Buildings Survey Collection, Prints and Photographs Division).

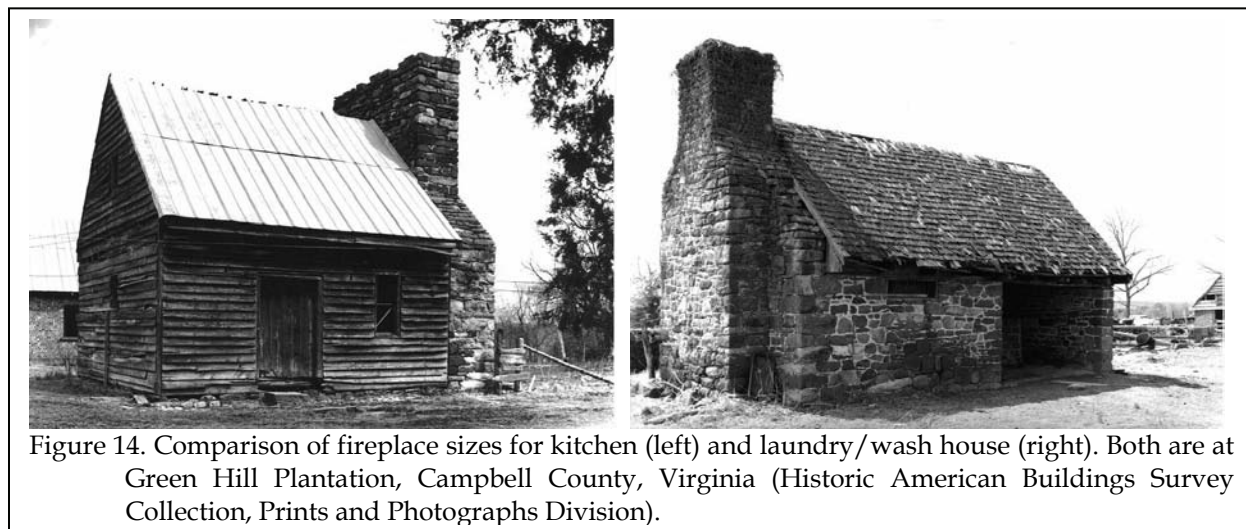
Figure 14. Comparison of fireplace sizes for kitchen (left) and laundry/wash house (right). Both are at Green Hill Plantation, Campbell County, Virginia (Historic American Buildings Survey Collection, Prints and Photographs Division).
